## HISTORICAL SHORELINE EROSION: DEADMAN'S ISLAND

Dr. Chris Houser, Department of Geography, Texas A&M University

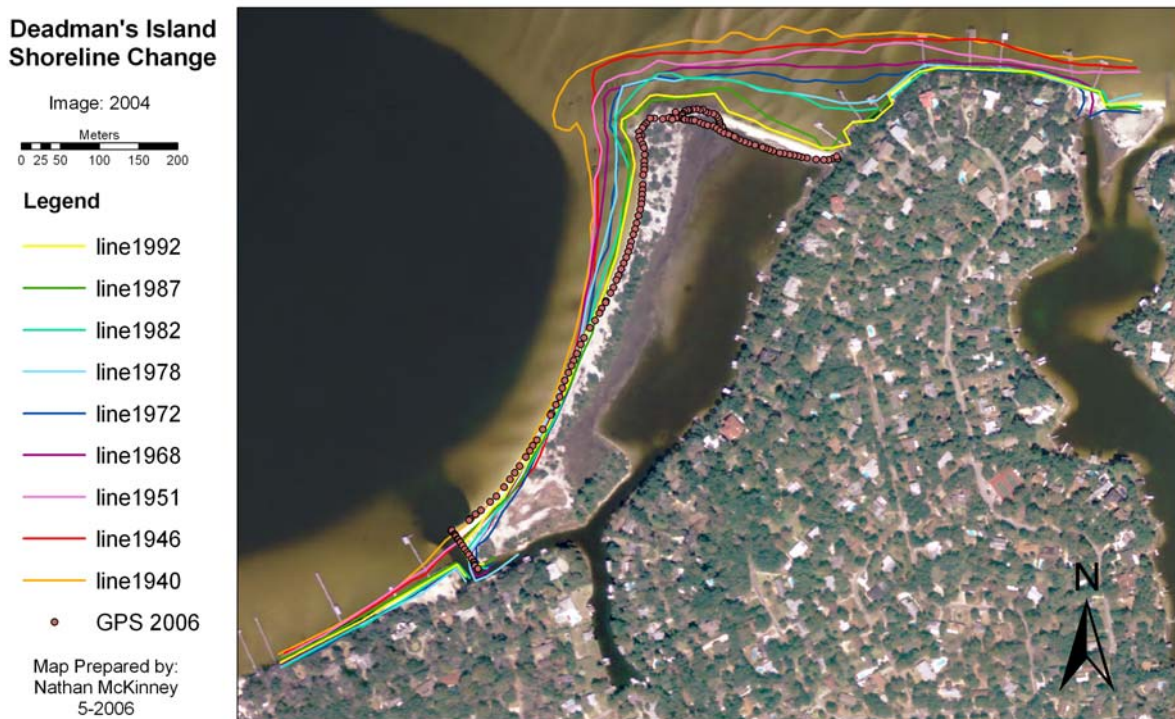
**ANALYSIS OF SHORELINE RETREAT:** Historical shorelines from 1940 through 2006 are shown in the satellite photograph below. Since 1940, both the northern and the western shorelines have retreated, with little to no change along the southwestern section of the island.

**Figure 1.** Satellite photograph of Deadman's Island (from 2004) showing historical and modern (2006) shorelines based on the analysis of aerial photographs.

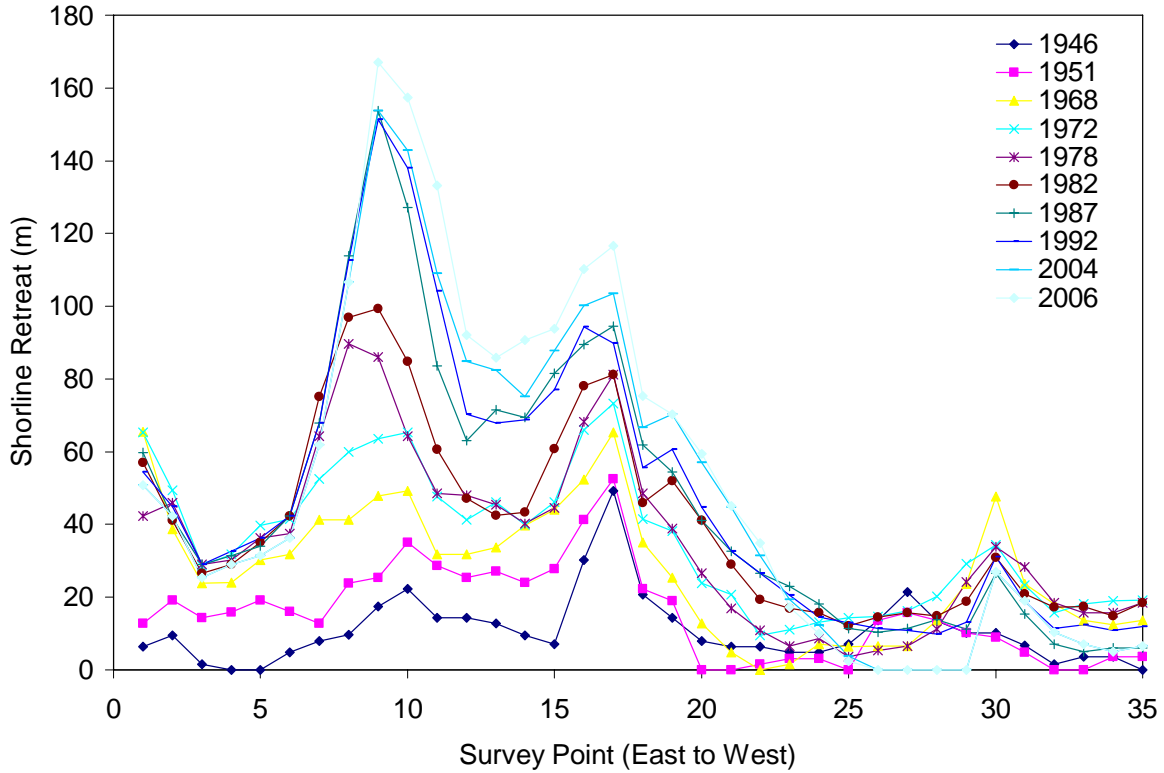
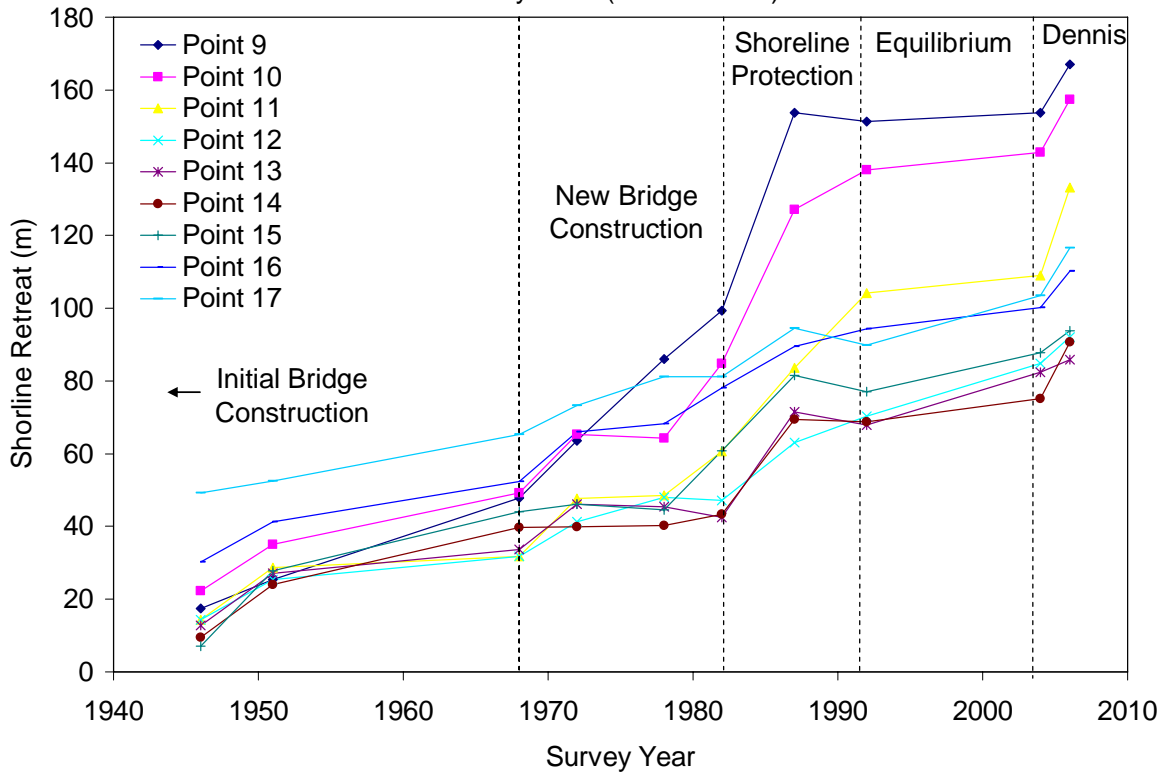
The amount of shoreline retreat for 35 equally-spaced points (from east to west) is shown in the following graph. Significant erosion (of 49 m) was first evident at the (northwestern) tip of the island, while the average shoreline loss was only 10 m. While this point continued to erode by a further 67 m through 2006 the rate of change was only  $1.2 \text{ m yr}^{-1}$ . In comparison, the northeastern extent of the island exhibited relatively little erosion between 1940 and 1946 ( $17.5 \text{ m}$  or  $3 \text{ m yr}^{-1}$ ), the erosion continued at an average rate of  $2.7 \text{ m yr}^{-1}$ . However, the erosion was constant between 1940 and 2006. Between 1940 and 1982, it was  $2.3 \text{ m yr}^{-1}$  but increased dramatically to  $11 \text{ m yr}^{-1}$  between 1982 and 1987. After 1987, little shoreline change was observed at this location. This increased in erosion between 1982 and 1987 is consistent for all survey points (1-17) along the northern part of the spit.

**Figure 2.** Alongshore variation in shoreline retreat (from 1940) at 35 equally spaced survey points starting at the bluffs immediately east of the site. Also shown (b) is the shoreline retreat by survey year for the northern shoreline (points 9-17).

Based on the analysis of shoreline retreat, there are 3 changes to the updrift supply of sediment that could be responsible for the erosion of Deadman's Island. The initial erosion of the site may be a response to the initial construction of "Three-Mile Bridge", which would have restricted all sediment from Butcherpen Cove reaching Deadman's Island. When the modern version of 3 Mile Bridge was completed the sediment may have been further restricted by the extension of the bridge ramp. Finally, construction of protective structures along the bluffs immediately east of the site in the 1980's would have removed the "local" supply of sediment. These changes to the sediment supply of Deadman's Island are apparent (and identified) in Figure 2b.

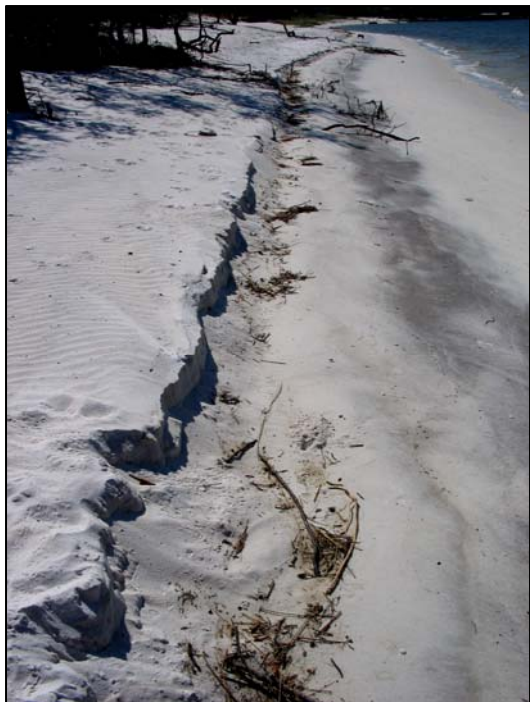
**Figure 4.** Shoreline erosion following a small frontal storm in October 2005.

**DISCUSSION:** Erosion results from an imbalance in the sediment budget- more sediment is transported out of a control volume by waves and currents then is brought in from either cliff erosion or alongshore and cross-shore sediment transport. While Morgan suggests that the sediment supply for Deadman's Island is from the bluffs immediately east of the site, the large offshore shoal and the results of the statistical analysis suggests that sediment is supplied along the entire length of the shoreline from Naval Live Oaks (Butcherpen Cove) to the bluffs immediately east of the site. Sediment is eroded from these sites in response to continuing sea-level rise since the last low-stand and in response to storm activity, and sediment is transported alongshore (to the west) in response to alongshore currents during frontal storms. As the source of sediment is limited, Deadman's Island will erode. An examination of the sedimentary structures along the northern part of the island suggests that part of the shoreline retreat is the result of sediment overwash and island rollover during large storms (see Figure 3) with north winds. Erosion is also evident following small frontal storms when north winds generate sizeable "chop" over Escambia Bay (see Figure 4).

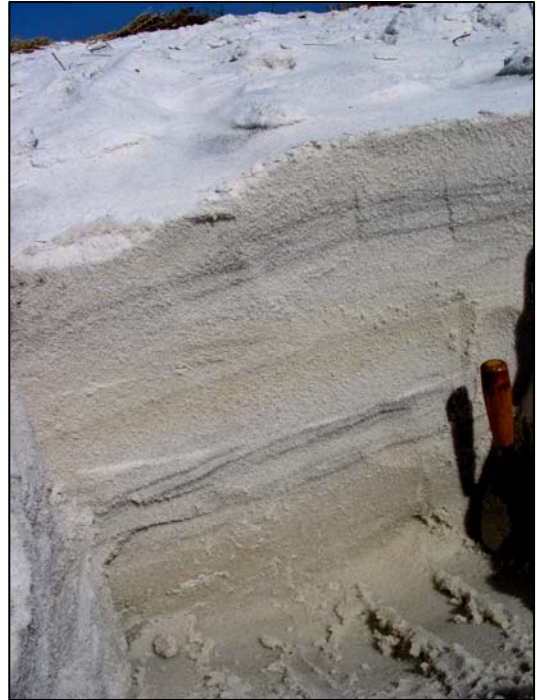
**Figure 3.** Sedimentary structures (near survey point 9) along the northern shoreline of Deadman's Island. The upper band of dark sediment is a response to Hurricane Dennis, while the bottom layer is a response to either Hurricane Opal or Erin.
